CLUTCH AND PEDAL LINKAGE

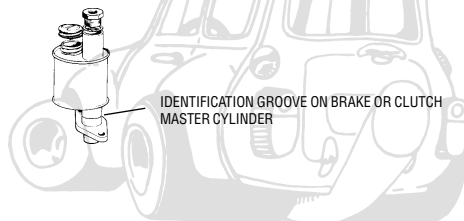
MASTER CYLINDER THAT HAS 2 RING SEALS CAN BE IDENTIFIED BY A SINGLE GROOVE AROUND BODY BELOW FLUID RESERVOIR, AS PER DIAGRAM BELOW.
